# Tech Digest

Published by Myanmar Engineering Society

# ASEAN OUTSTANDING ENGINEERING ACHIEVEMENT AWARD YEAR 2014

## Thaukyegat (2) Hydropower Station (3 x 40 MW, 605 GWh)

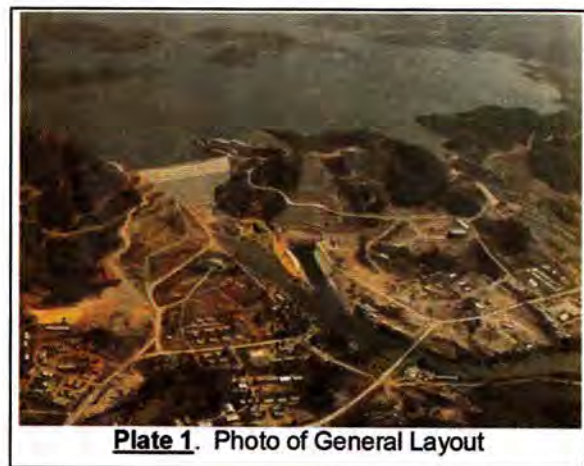
**(E) Project Layout.** Major components of the project/power station are; main dam, diversion facility, waterway, spillway, power house and switchyard. It is best illustrated by a drawing and corresponding picture as follow;

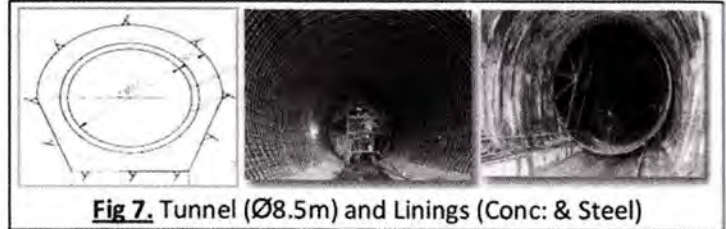
Reservoir water was conveyed to power house through Ø 8.5m tunnel with gate shaft for power generation. The tunnel is concrete lined in upper portion and steel lined in lower

**Fig 7.** Tunnel (Ø8.5m) and Linings (Conc: & Steel)

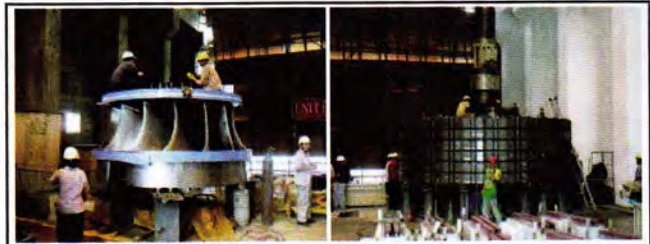
Electrical equipments include generator, transformer, control-gears in switchyard and power house, whereas mechanical equipment includes turbine, gate, valves, pipes, etc (E & M). Penstock, Radial gate, Bulkhead gate and steel liner of waterway are grouped as hydraulic steel structure (HSS). They were supplied and installed by respective contractor.

**Fig 10.** Turbine and Generator

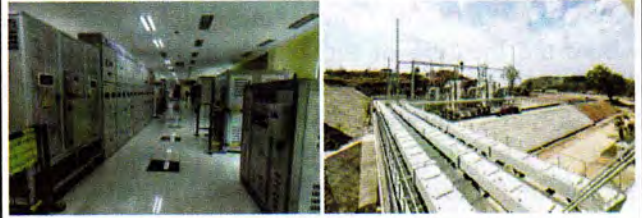
**Fig 11.** Controls and Switchyard
